# ARBORICULTURAL SURVEY REPORT

Land South of Guarlford  
Road, Malvern

April 2020

Summary table		
Site Name:	Land South of Guarlford Road, Malvern	
Project reference:	C.3492	
Site Address:	Guarlford Road, Malvern	
Nearest Postcode:	WR14 3QS	
Central Grid reference:	SO 79948 45206	
Local Planning Authority:	Malvern Hills	
Relevant planning policies:	South Worcestershire Development Plan Policies: 5: Green Infrastructure, 22: Biodiversity and Geodiversity, 23: The Cotswolds & Malvern Hills AONBs, 25: Landscape Character.	
Statutory Controls:	Tree Preservation Order	Conservation Area
	No	No
Soil Type: (Source: BGS online soils map © NERC 2019)	Superficial/Drift	Bedrock
	Head - Clay, Silt, Sand And Gravel.	Sidmouth Mudstone Formation - Mudstone.
Topographical Survey:	Ref: 1109, dated March 2020 - Geoff Perry Associates Limited	
Report author:	Ellen Boardman - Arboriculturist	
Checked by:	Paul Barton - Director	
Date of issue:	27th April 2020

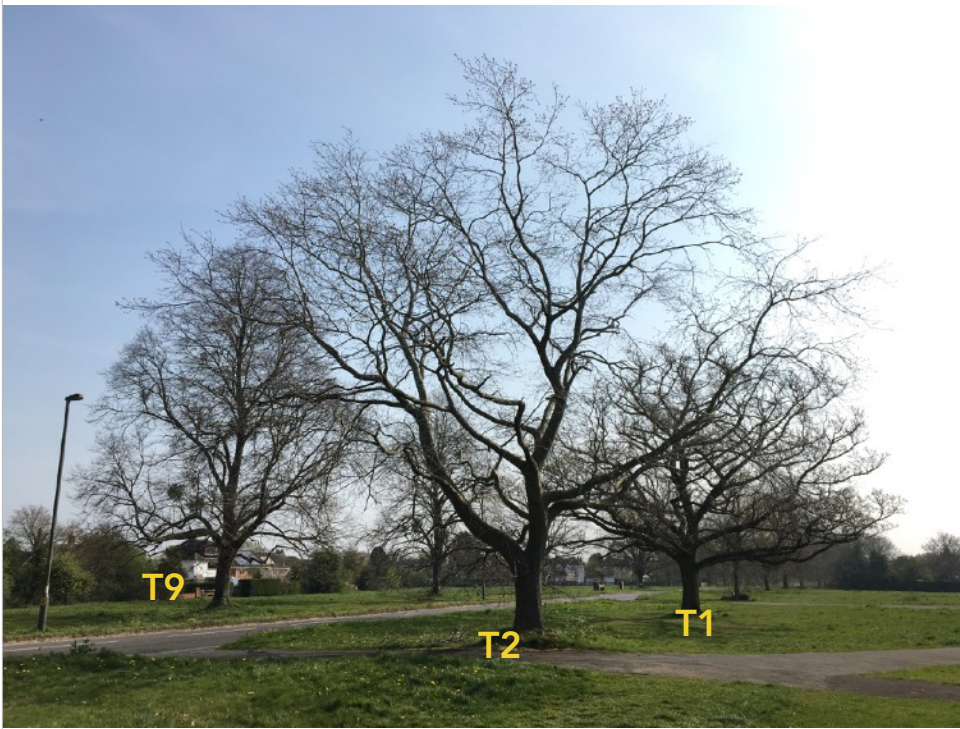
PHOTO 1: Trees alongside Guarlford Road to the north of the site adjacent to the proposed development access.

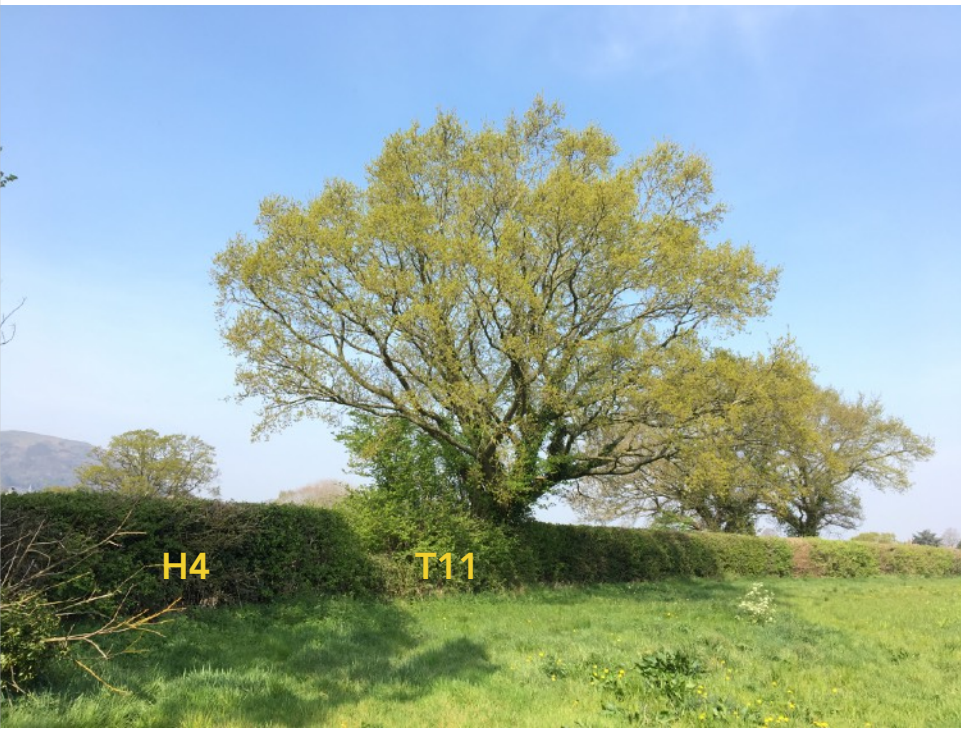
PHOTO 2: T11 and H4 on the western edge of the site, within the area proposed for green infrastructure.

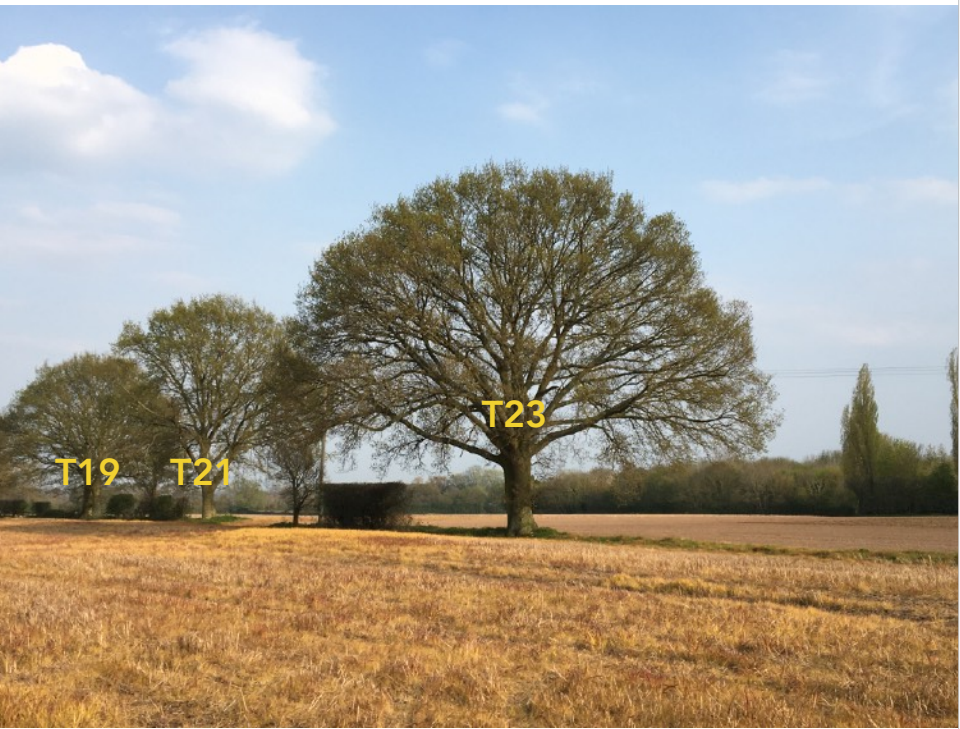
PHOTO 3: T19, T21 and T23, high quality English oak trees, part of an old field boundary. G3 is in the background.

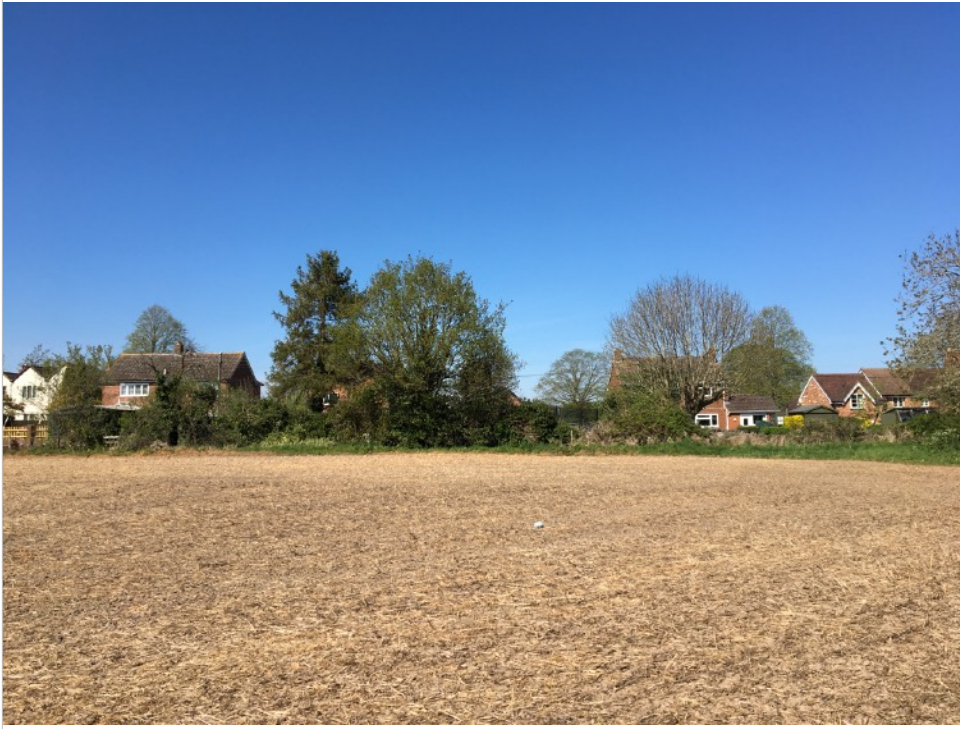
PHOTO 4: Looking towards the residential properties to the northern boundary of the site, T50 - 52.

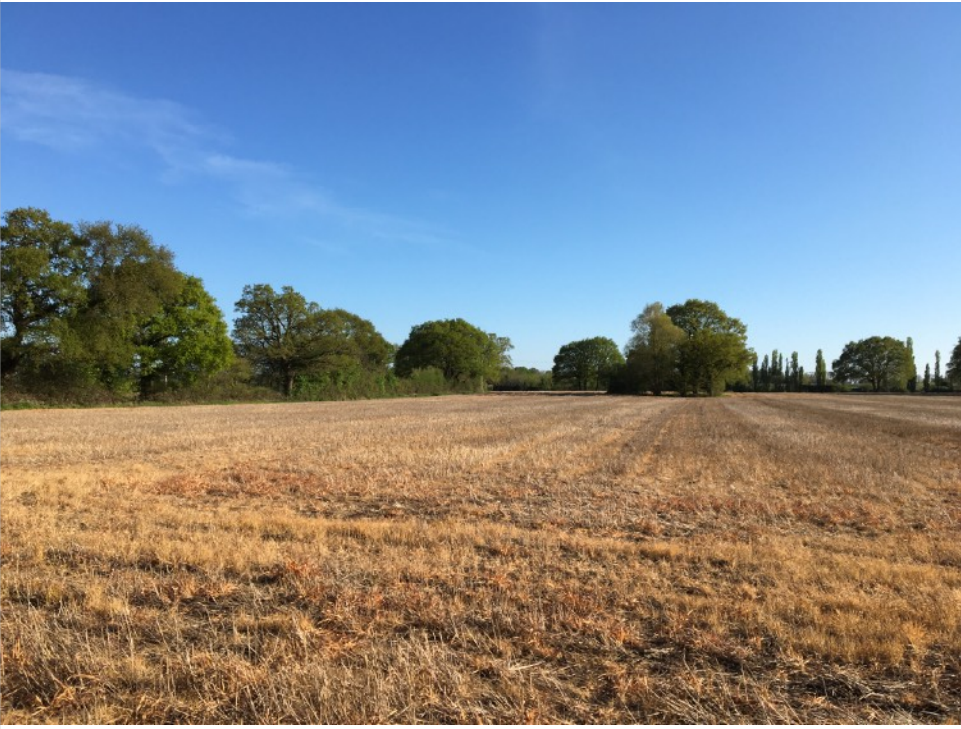
PHOTO 5: The eastern boundary of the site visible to the left hand side of the photo, T69 - 78, and the southern boundary, to the right hand side, T18 - 23.

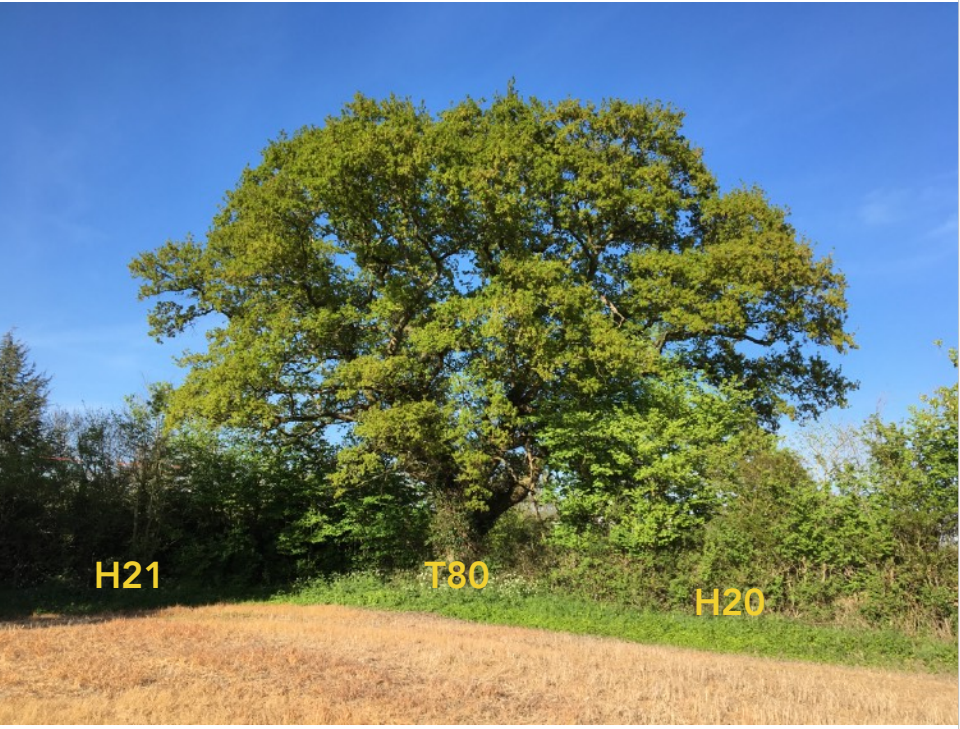
PHOTO 6: T80 in the north eastern corner of the site. H20 runs along the eastern boundary and H21 along the northern boundary.
