# A Conservation Management Plan for Herefordshire Beacon ('British Camp'), Colwall, Herefordshire

Prepared by Peter Dorling, Senior Projects Archaeologist  
Herefordshire Archaeology,  
Herefordshire Council

## Final Version

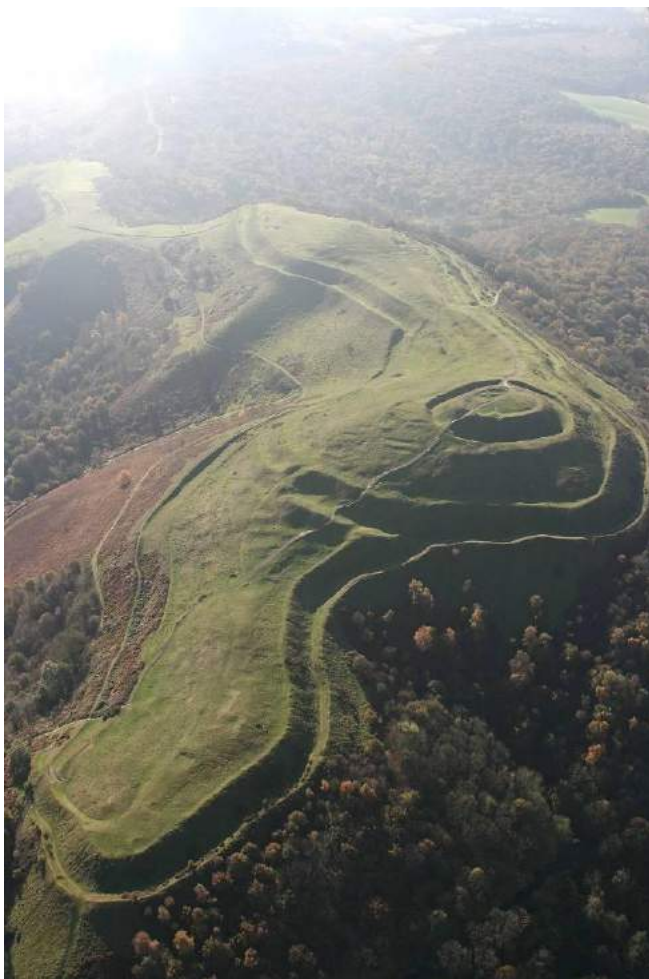
*Figure 3: Northern summit of the Herefordshire Beacon ridge, looking north from the bank around the southern summit. Note the at first sight confusing array of ramparts.*

This hillfort comprises an at first sight bewildering complex of earthworks rising in serried ranks of (chiefly) ramparts and ditches (figure 3) following a ‘serpentine’ course along the contours on all sides of the ridge-top (Bowden, 2005, 19). The earthworks are roughly (but not entirely) concentric and represent an evidently complex build-sequence (see 2.1.1, below). They are most economically described from the outside, inwards towards the summit; but the inter-relation of the earthworks needs to be borne in mind, since each set of earthworks represents a modification from an inherited pattern.

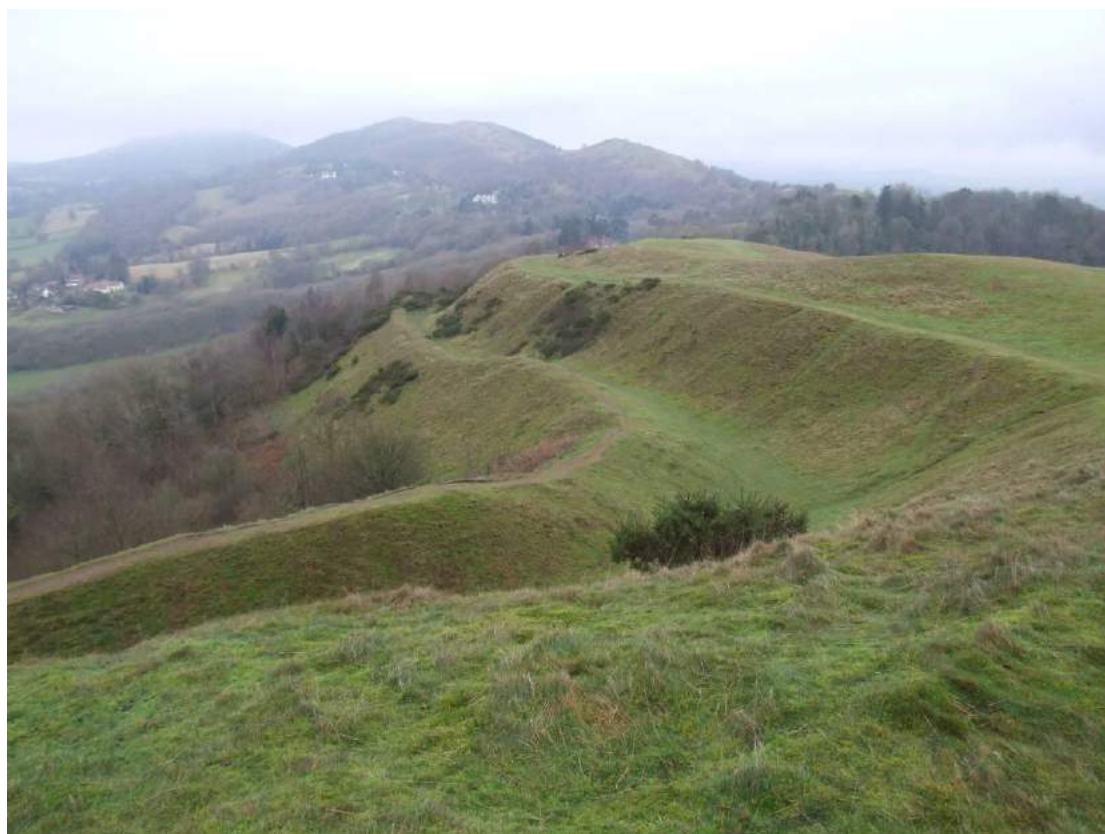
*Figure 4: The northern circuit of hillfort earthworks from beneath the ringwork, looking north towards the Worcestershire Beacon. Note especially the slight inner bank above the upper scarp, the deep ditch, and the counterscarp bank beyond this.*

In contrast, the bank surmounting this massive scarp is uniformly slight, where it is traceable at all (figure 4). For most of its course it is barely detectable and at most it stands to a height of 0.5m, except where, for very short stretches, it is heightened above original entrances through the bank. There is a marked absence of quarry scoops or ditches on the inside of the bank, although scarping of the hillside rising behind the bank along much of its course could be the source of material that has in-filled such quarries; or they could have been filled with occupation debris either dumped into these scoops or quarry ditches, or arising out of successive construction of occupation structures, as demonstrated by excavation at such sites as Croft Ambrey in the north of the county.

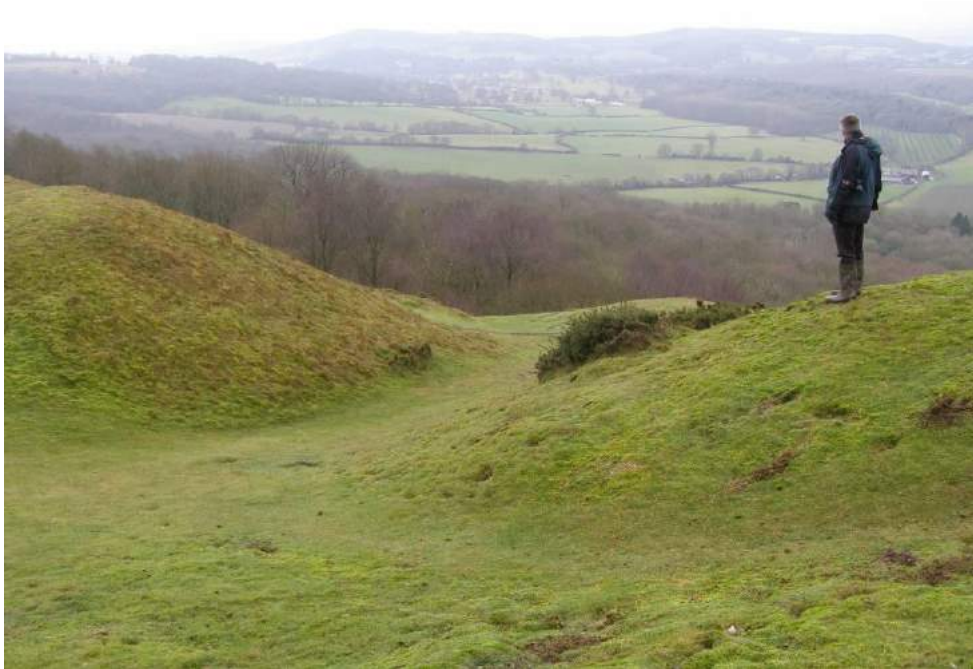
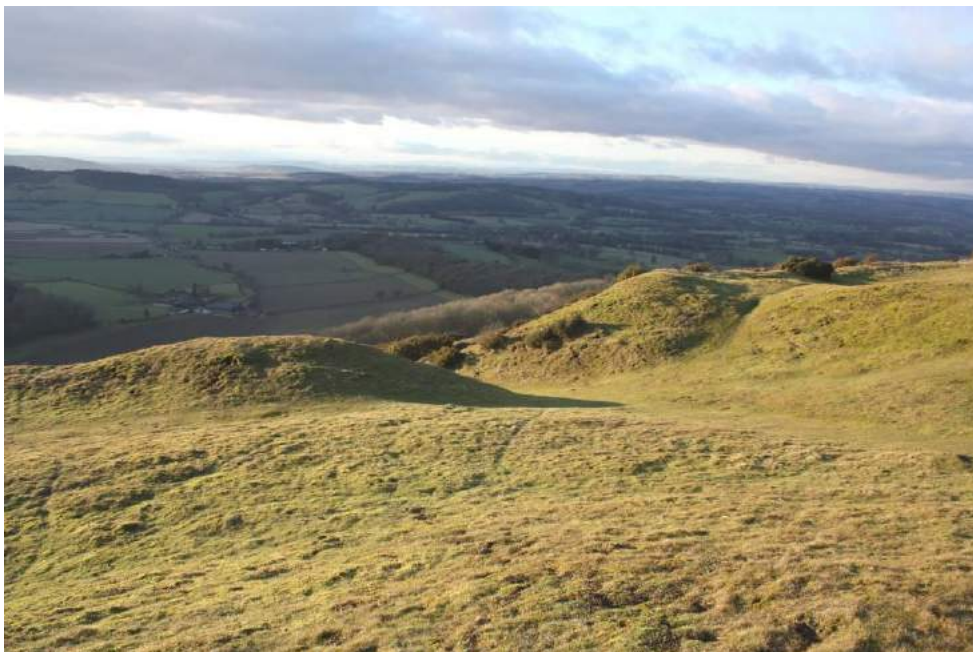
The seemingly best-preserved entrance, on the western side, lies across the narrowest part of the ridge obliquely opposite (and southwards from) this eastern entrance (figures 5A and 5B). A track-way on a broad terrace cut into the hillside approaches this entrance from the south/south-west. Flanking earthworks mark its passage through and over the counterscarp bank, and isolate the entrance way from the ditch on either side. The inner bank on either side of the entrance is built up to as much as 1.0m in height and turns inwards slightly to mark the presumed position of a gateway.

*Figures 5A and 5B: The western entrance from the north-east and south-east respectively.*

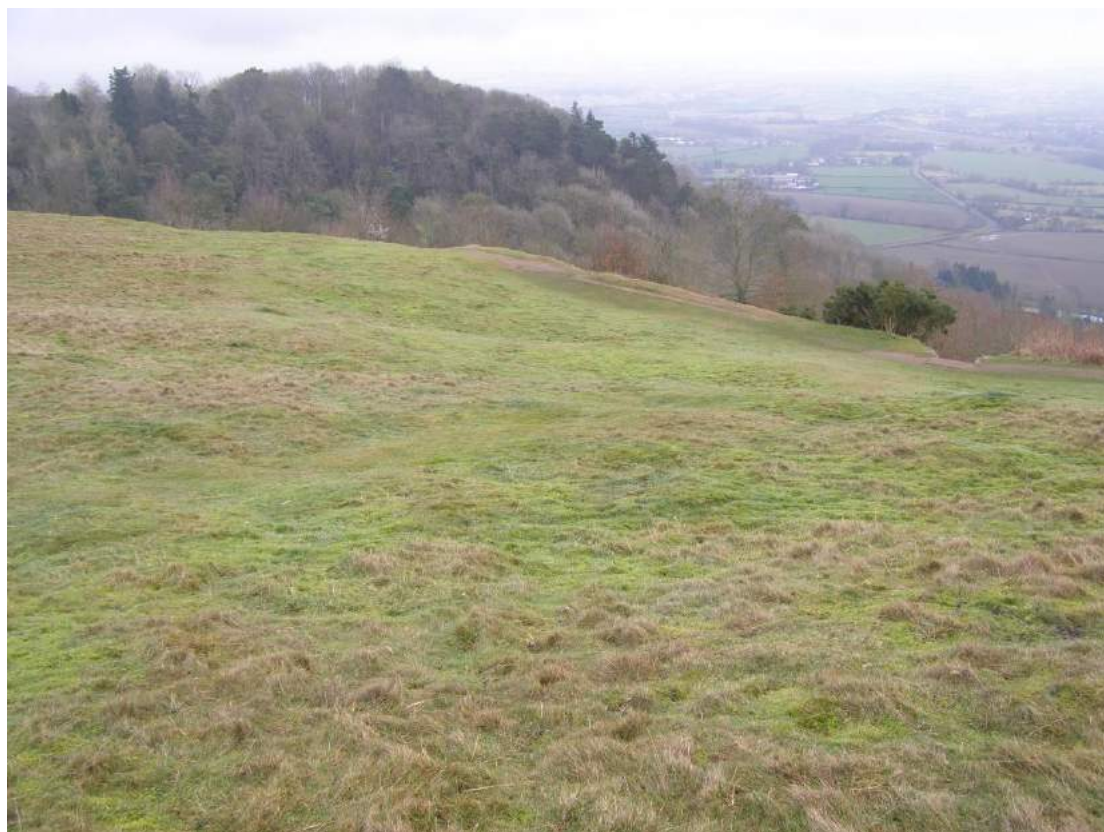
*Figure 6: Iron Age building stances and terraces on the north-east facing flank of the ridge within the northern loop of defences overlooking Wynds Gap.*

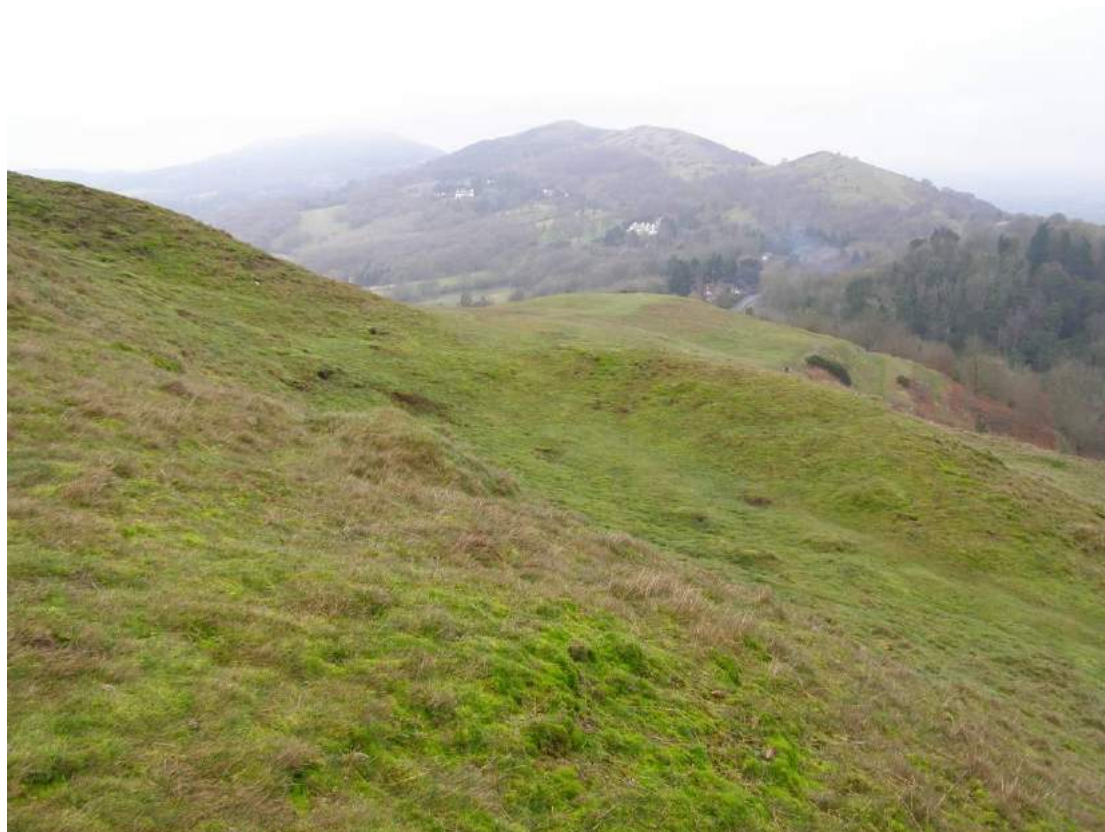
*Figure 7: The claimed entrance through the 'Phase I' ramparts. Field inspection for the current Plan has led to the suggestion that these earthworks in their current configuration may represent instead a reworking or "new" creation of an entrance here. This would have provided access into an outer enclosure of the ring-work, itself involving reuse of the "primary" Iron Age hillfort ramparts.*

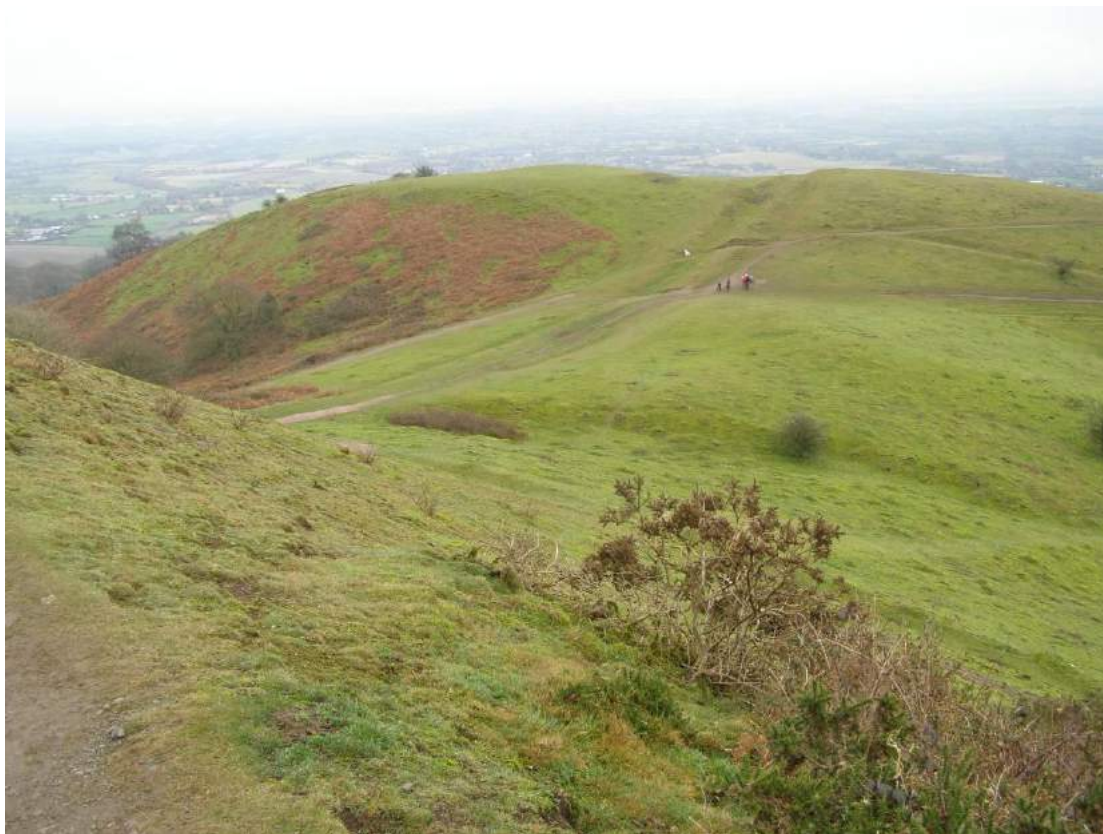
*Figure 8: The Shire Ditch extending from the southern end of the hillfort onto Broad Down.*

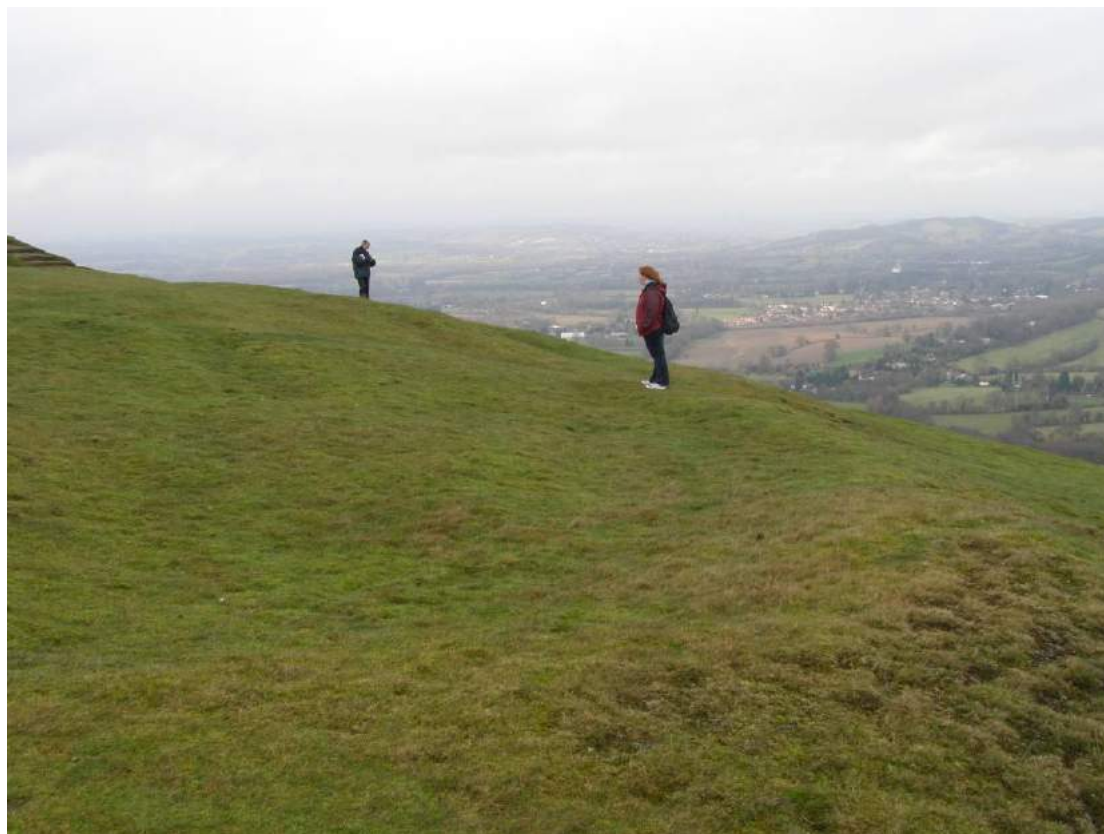
*Figure 11: Area east of the summit ring-work looking north. The curving bank in the foreground and on which the two figures are standing traces the only surviving portion of what appears to be the earliest enclosure on the hill.*

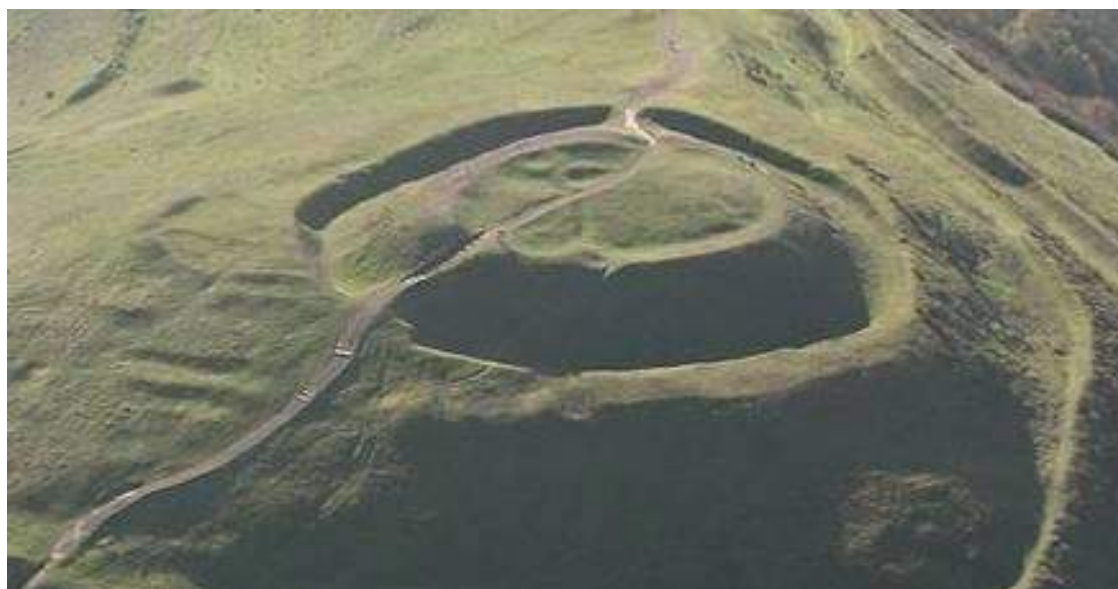
- The line of the hill top enclosure beyond the ditch of the ring-work is not fully concentric with that later earthwork, and its course is judged to have been cut by that ditch (figure 12)

*Figure 12: The curving bank of the possible earliest enclosure is visible at left centre, with the ditch of the medieval ringwork cutting through it. Three-quarters of the earlier enclosure could in this way have been destroyed when the ring-work was built.*

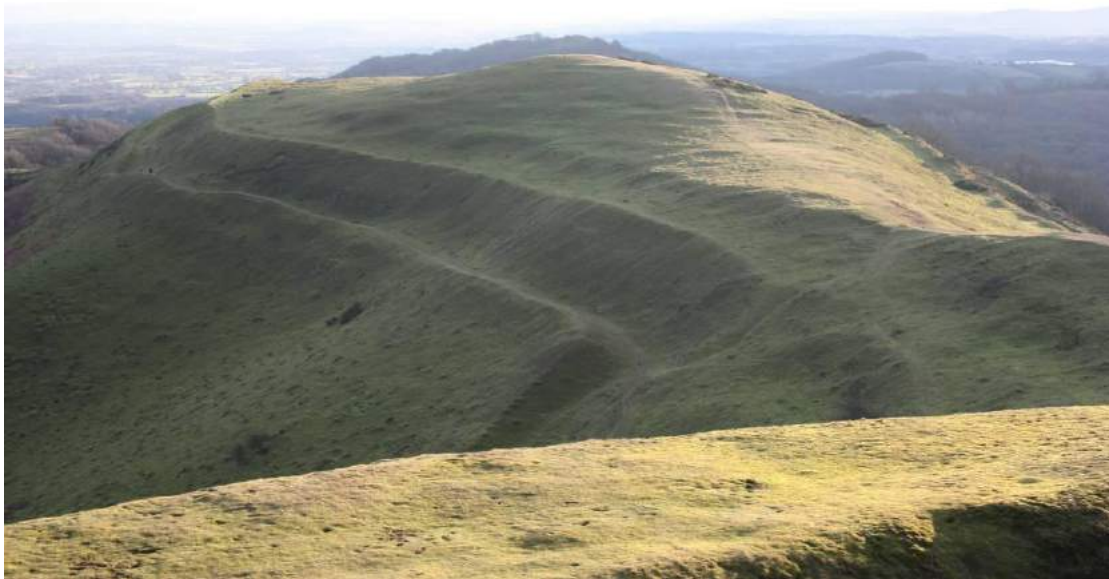
*Figure 13: The southern loop of ramparts looking south from the ring-work. Note especially the near-continuous quarry ditch within the uppermost rampart, which continues fully to the base of the summit ridge on which the ring-work stands. This primary construction was subsequently amended, as shown by the sharply-angled recut evident in the centre of this image.*

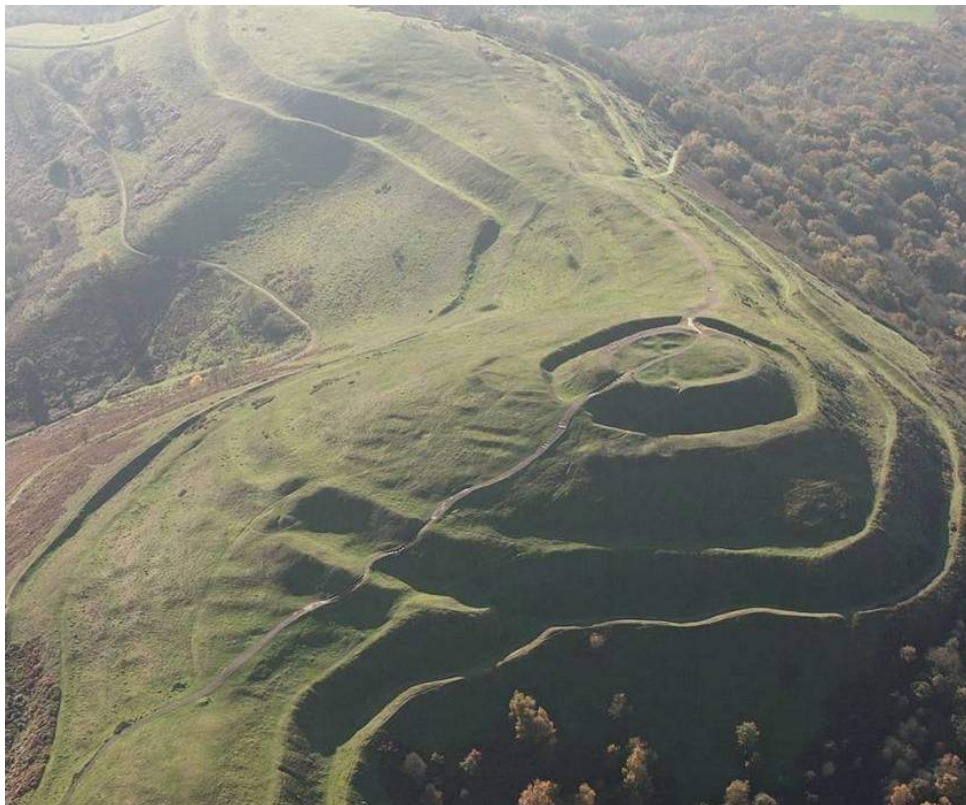
*Figure 14: Aerial view of Herefordshire Beacon from the north. Detail showing building platforms and terraces on the north-eastern flank of the summit.*

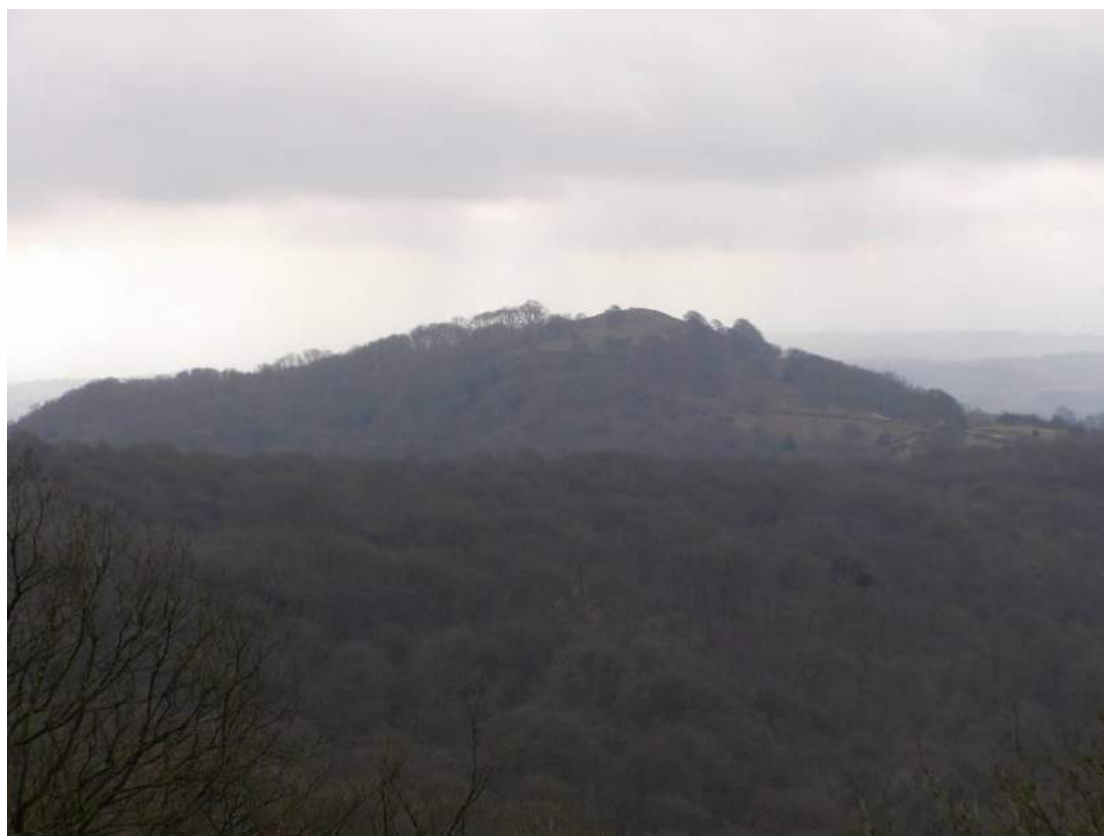
*Figure 15: Midsummer Hill as seen from the ridge on which the Herefordshire Beacon Hillfort stands (Hollybush Hill at left centre).*

What is incontestable is that the two forts are inter-visible under most weather conditions (figure 15). They are separated by only just over 2 kilometres, and although there are considerable drops and rises in elevation along the

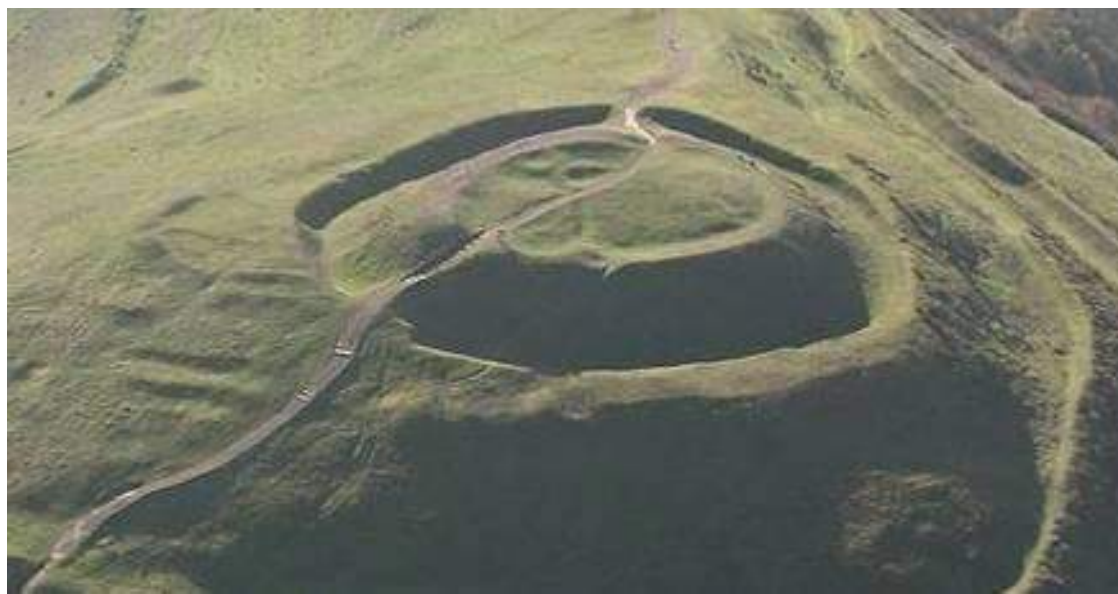
*Figure 16: The ring-work from the air from the north. Note the symmetry of the bank around the interior and the hollows within this. Material from the ditch was used to construct the central mound while some material may have been piled up beyond the ditch, particularly on the north side.*

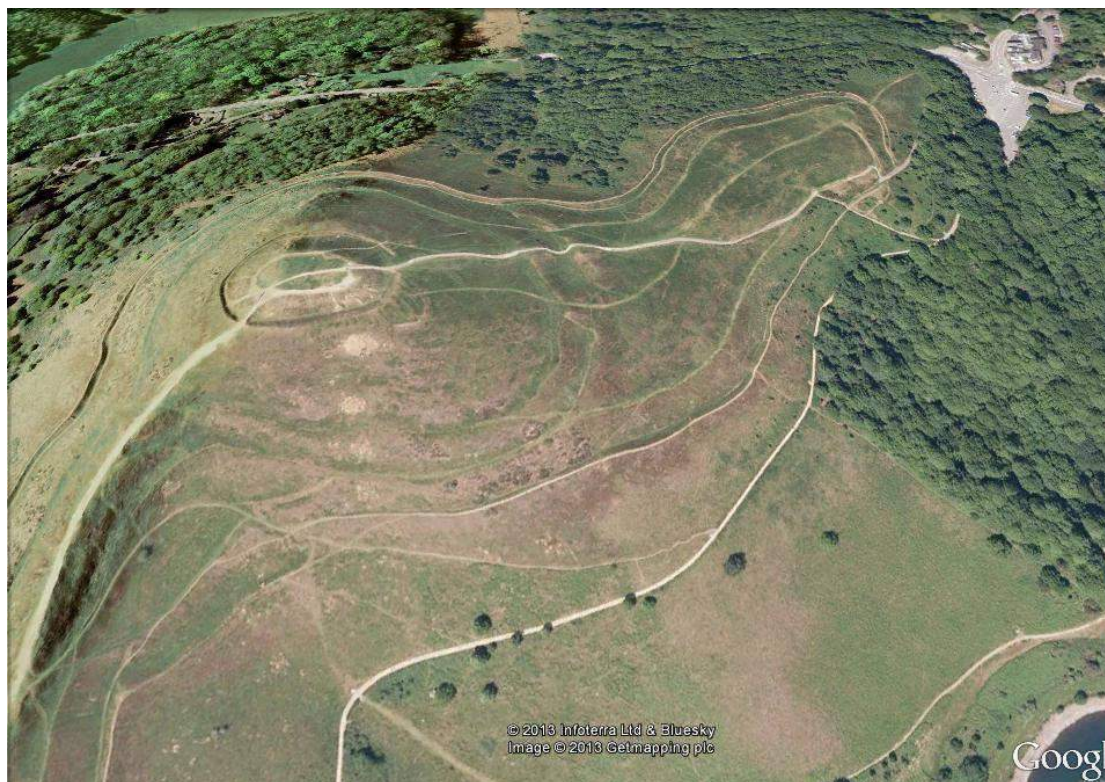
*Figure 17: Part of the network of paths covering Herefordshire Beacon, the car park can be seen top right. Areas of rabbit burrowing can be seen as pale areas on successive slopes running down from the hill summit. Areas of extensive scrub woodland can be seen beyond the area of the monument on the flanking slopes to the north-west, north and north-east. (©Google Maps)*

As described above recreational pressure has led to the surfacing (concreting) of some of the main paths through the hillfort and up to the summit of the hill (figures 17 and 19). This provision has probably in turn led to an increase in visitor numbers. The encircling ramparts also provide a natural route for a circular walk and as a consequence grass cover has been lost on the crest of the outer rampart (Figure 20). At present this is not causing undue erosion but requires regular monitoring preferably via fixed point photography and may require management action in the future. This might take the form of further surfacing but in a more sympathetic sacrificial material (local stone scalplings for instance) or the restriction of access to allow natural recovery to take place.

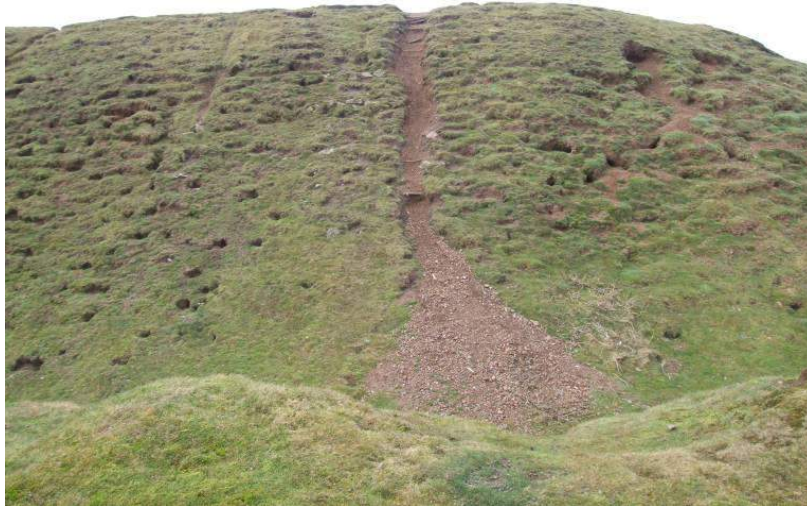
Gully formation on the steeper slopes is also an issue. The initial cause of these varies (footfall or mountain biking being common factors) but once the vegetation cover is broken erosion is caused by heavy rainfall washing out the often unstable stony material of the manmade earthworks (figure 18). Work needs to be carried out to repair these gullies. This will require scheduled monument consent and should be carried out in close consultation with English Heritage who may be able to provide grant aid towards the costs.

*Figure 18: Gullying and outwash on the ring-work caused by water erosion.*

The initial cause of these and at present less severe erosion scars also needs to be addressed, in particular the issue of mountain biking on the steep slopes of the monument. This is a difficult issue to warden, but an occasional intensive campaign of publicity and on-site warden or volunteer presence may help in reducing the problem.

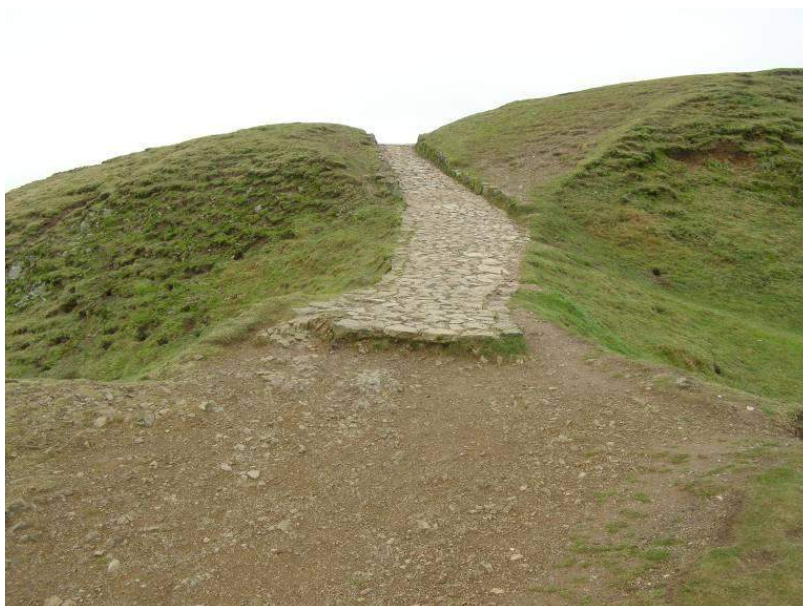
*Figure 19: Path erosion where the paved path meets an un-surfaced area.*

MHC constructed a concrete path at least 20 years ago for unknown reasons (see figures 17 and 19) but presumably to facilitate safe access and because a loose gravel path would wash down due to the steepness of the slope and number of visitors (pers comment – operations manager).

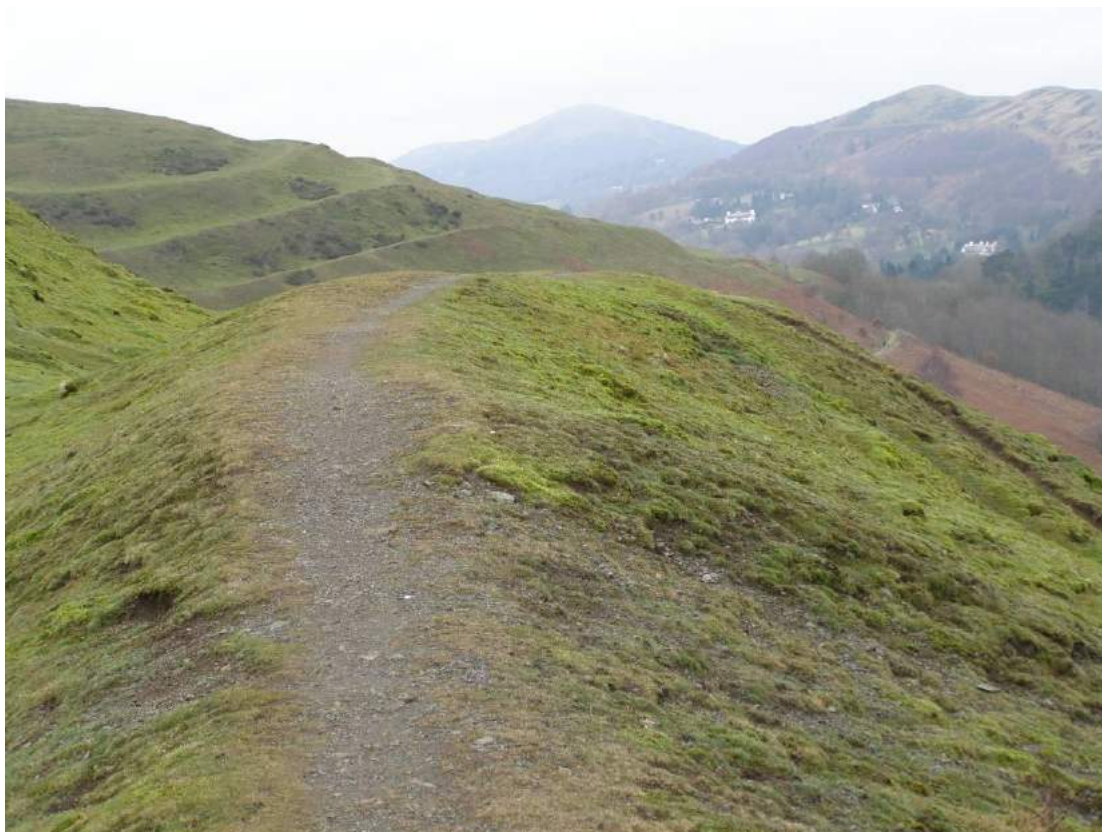
*Figure 20: Path erosion on the crest of the outer rampart. The route is a popular circular walk of around 2km. It may be that the material of the ramparts is robust enough to prevent further erosion but systematic monitoring is required.*

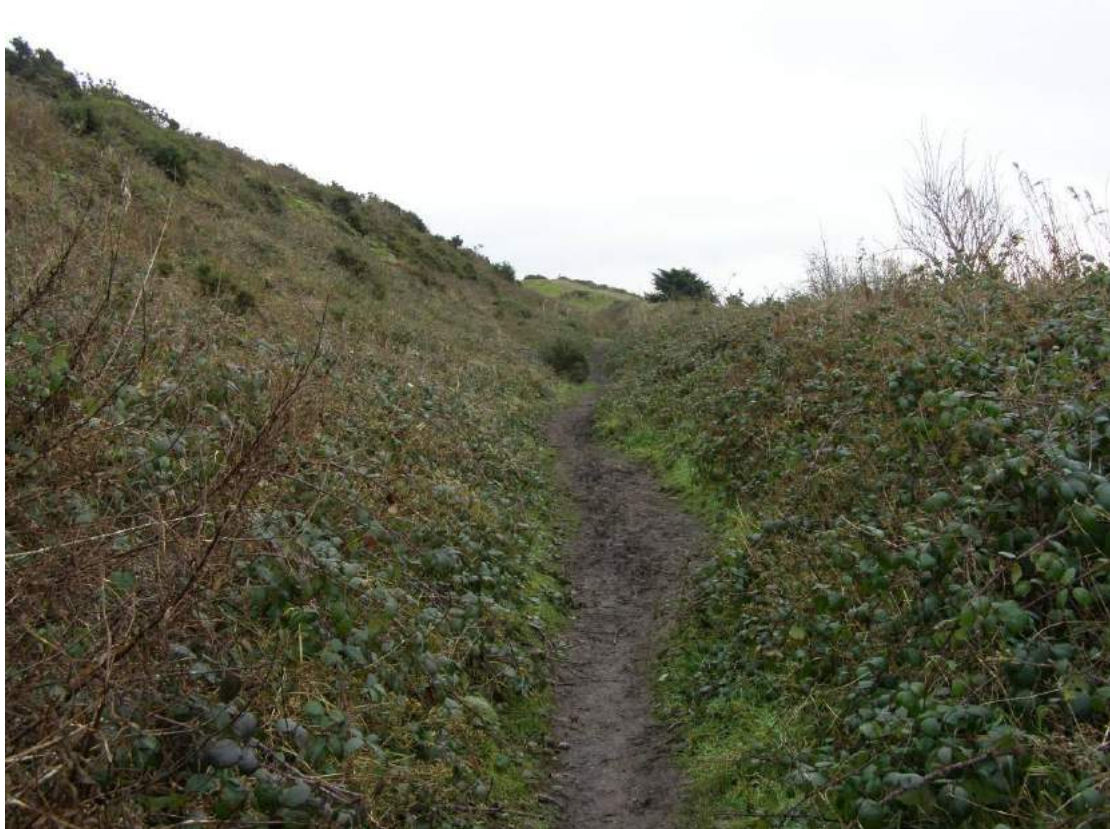
*Figure 21: Bramble, scrub and gorse between the inner and outer rampart on the south-west side of the site.*

Gorse is also an issue especially on the ramparts on the western and northern slopes of the hill (figure 21). This dense cover excludes light and causes loss of ground vegetation cover that can lead to erosion. Gorse however has important wildlife benefits, especially for birds, so reduction and control is recommended rather than complete removal. It should be restricted to the scaped slopes and controlled on a five year rolling programme on the ramparts themselves.
